Trouble-shooting program

This microcard deals with the VW vehicle models with breakerless transistorized ignition (TI-H)

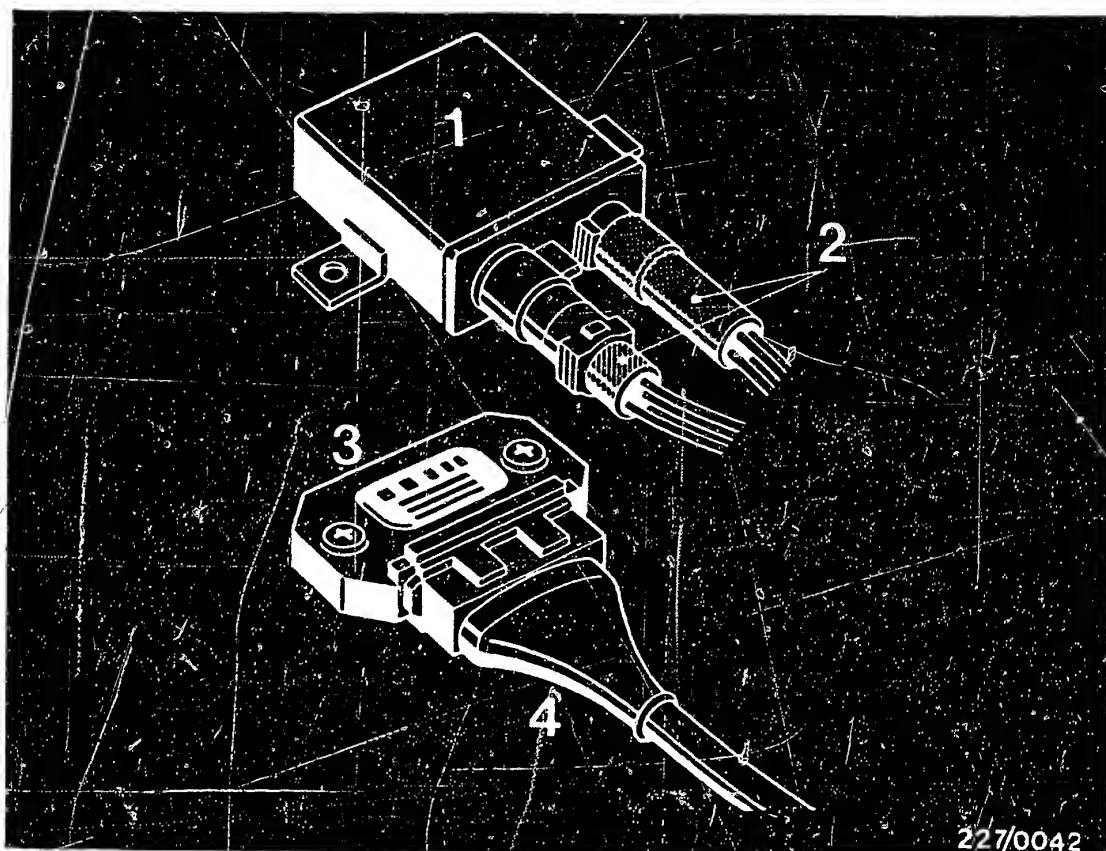
227/0042

Electrical terminal diagram
 Volkswagen

- 1 = DLS unit
- 2 = DLS connector
- 3 = TI-H trigger box
- 4 = Trigger-box plug

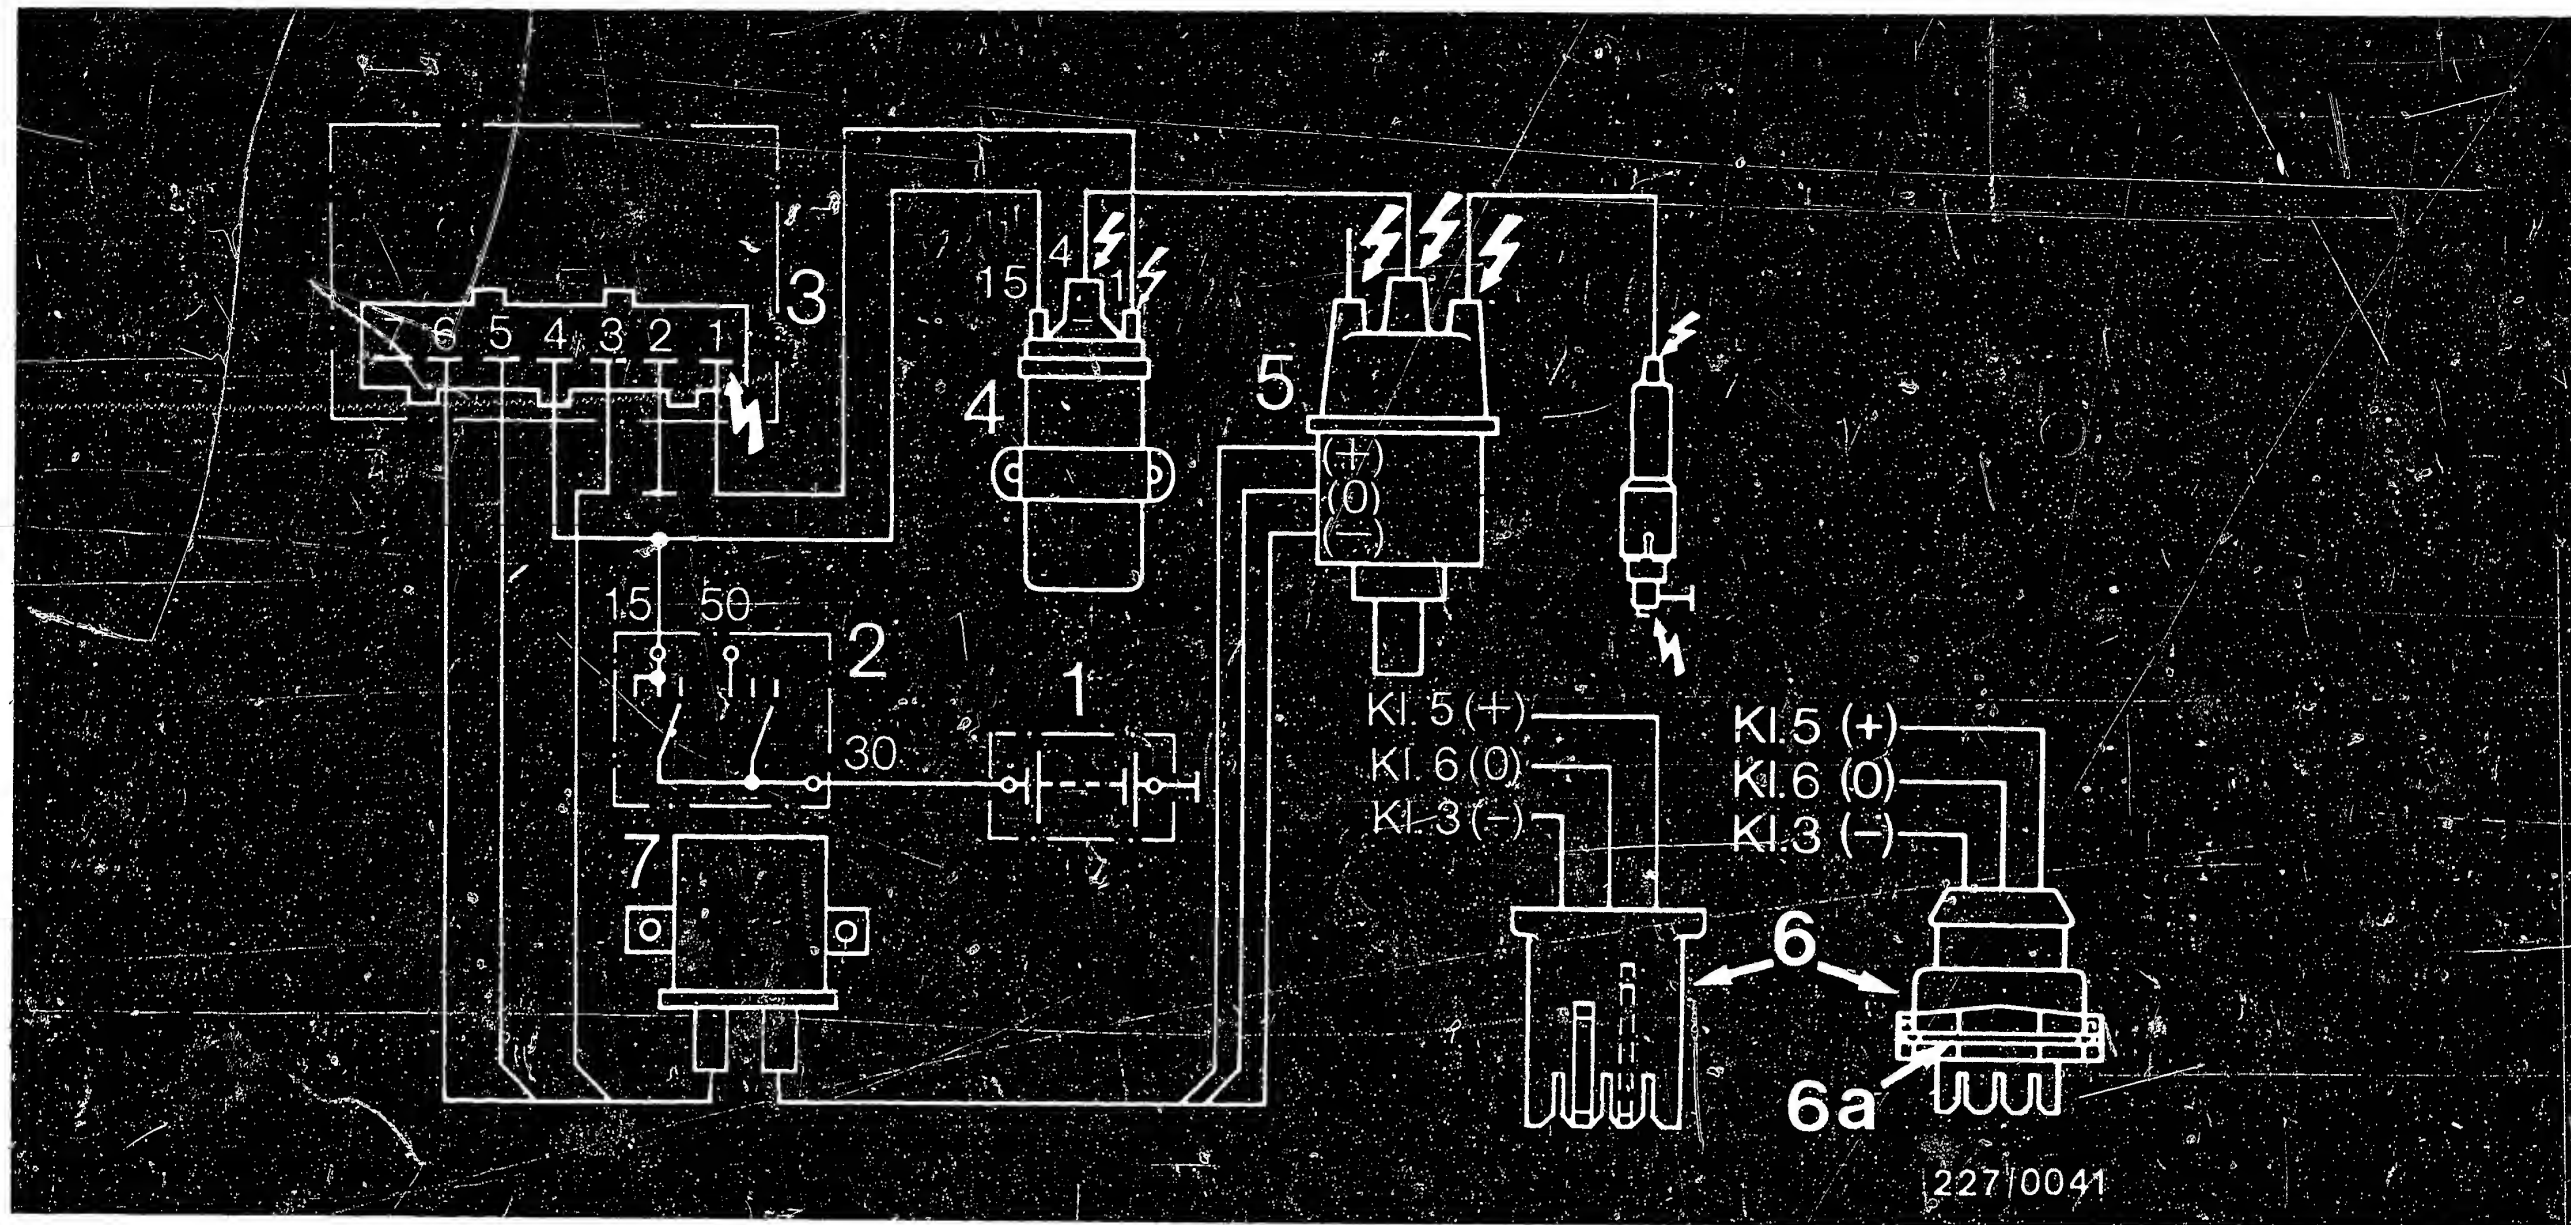
- 1 = Battery
- 2 = Ignition/starting switch
- 3 = Trigger box
- 4 = Ignition coil
- 5 = Ignition distributor

- 6 = Ignition-distributor connector
left - old version with guide lugs
right - new version

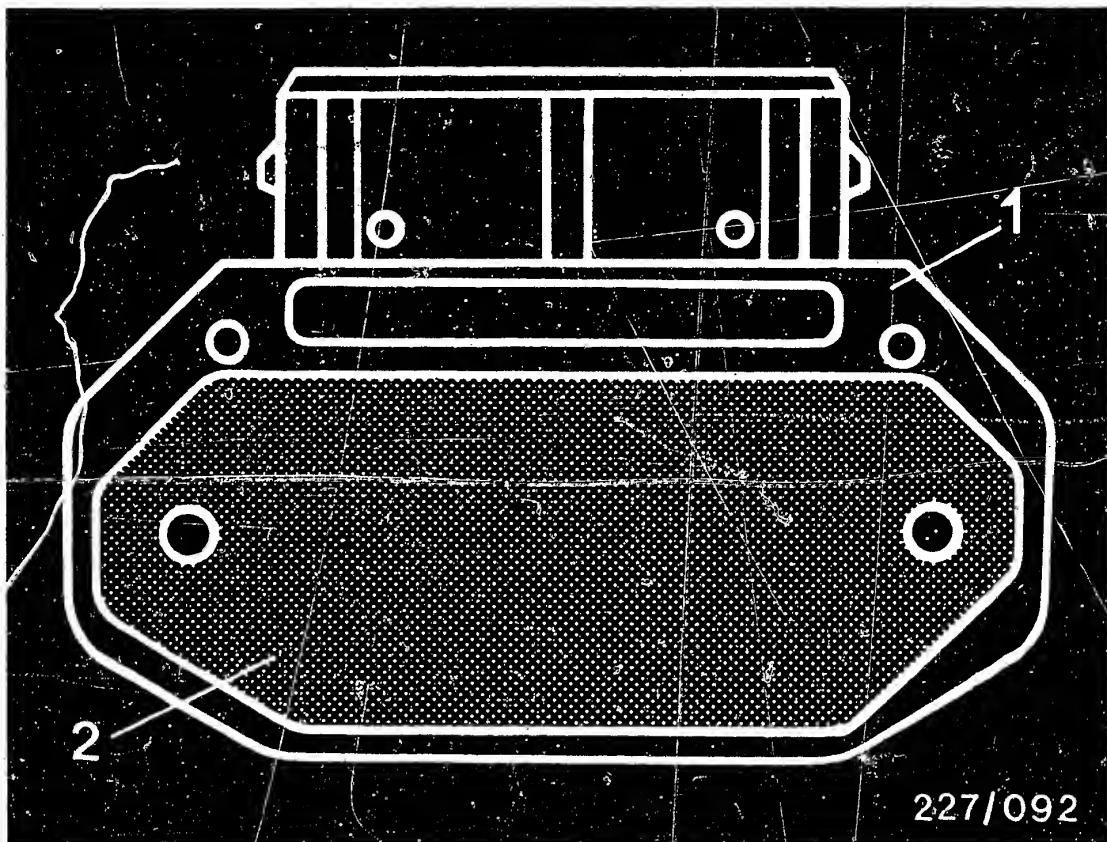
1 = Trigger box
2 = Base plate

- Before the trigger box is fitted, its base plate must be coated with thermal conduction paste. Only use an appropriate object to apply the paste (screwdriver, matchstick etc.). Thermal conduction paste is not to come into contact with painted surfaces.

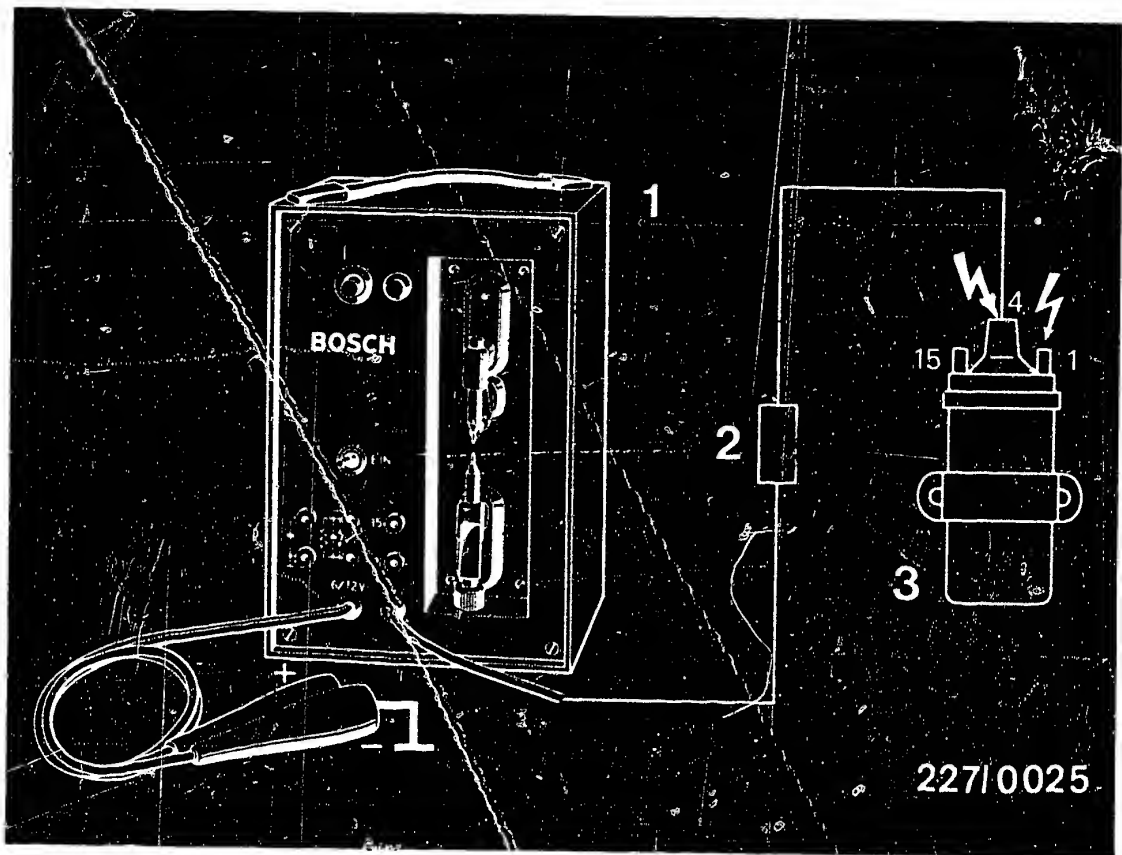
- 1 = Spark gap
- 2 = 5 k Ω sleeve-type suppressor
- 3 = Ignition coil

Danger arrows = dangerous voltages
(400 V - 25 kV)

- In order to prevent the trigger box from being irreparably damaged, when using a spark gap, an interference-suppression resistor of at least 2 k Ω must be connected between the spark gap and ignition coil terminal 4, e.g. sleeve-type suppressor (5 k Ω) 0 356 500 001.
- In the case of ignition distributors with engine-speed limitation the ignition distributor side terminal 4 must have 1 k Ω interference suppression.
Operation without interference suppression will lead to the destruction of the trigger box.

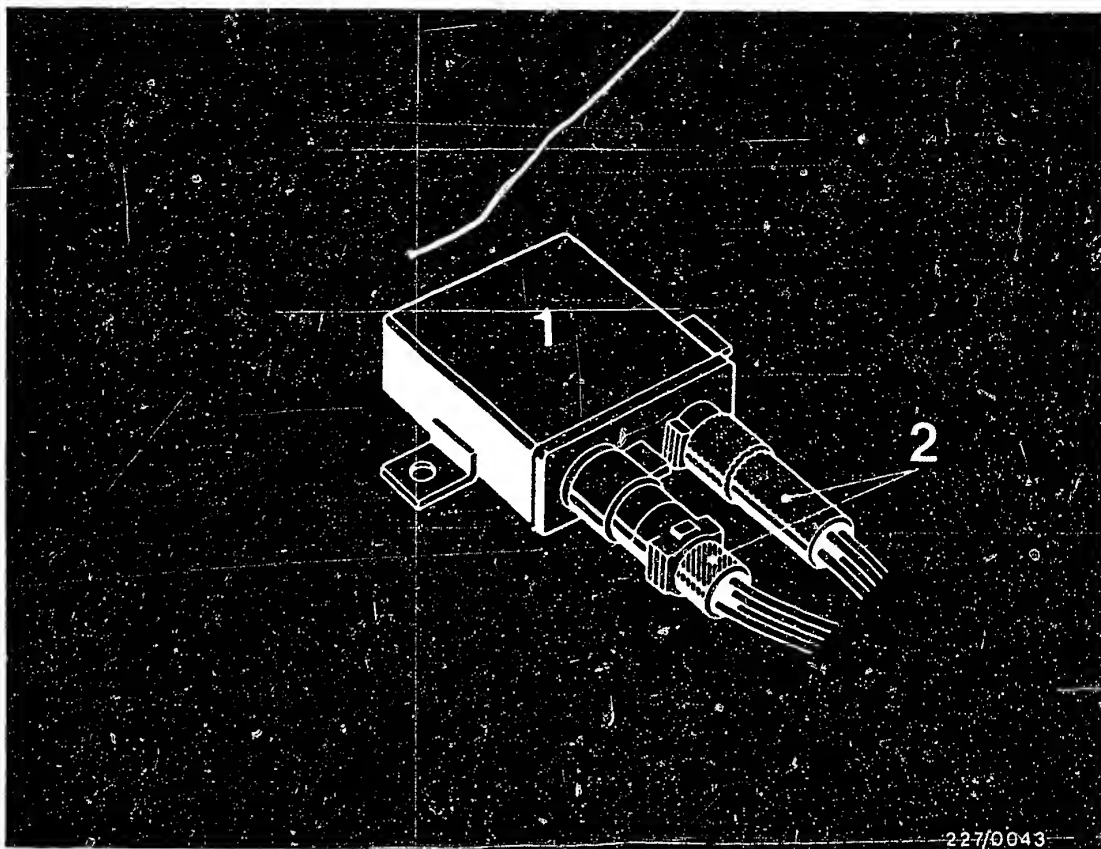
1 = DLS unit
2 = DLS connector

Visual examination: Remove both plugs from DLS unit (see illustration) and check contacts for oxidation and secure fastening (remedy defects). Plug both plugs back onto the DLS unit. If customer complaint not remedied, continue testing.

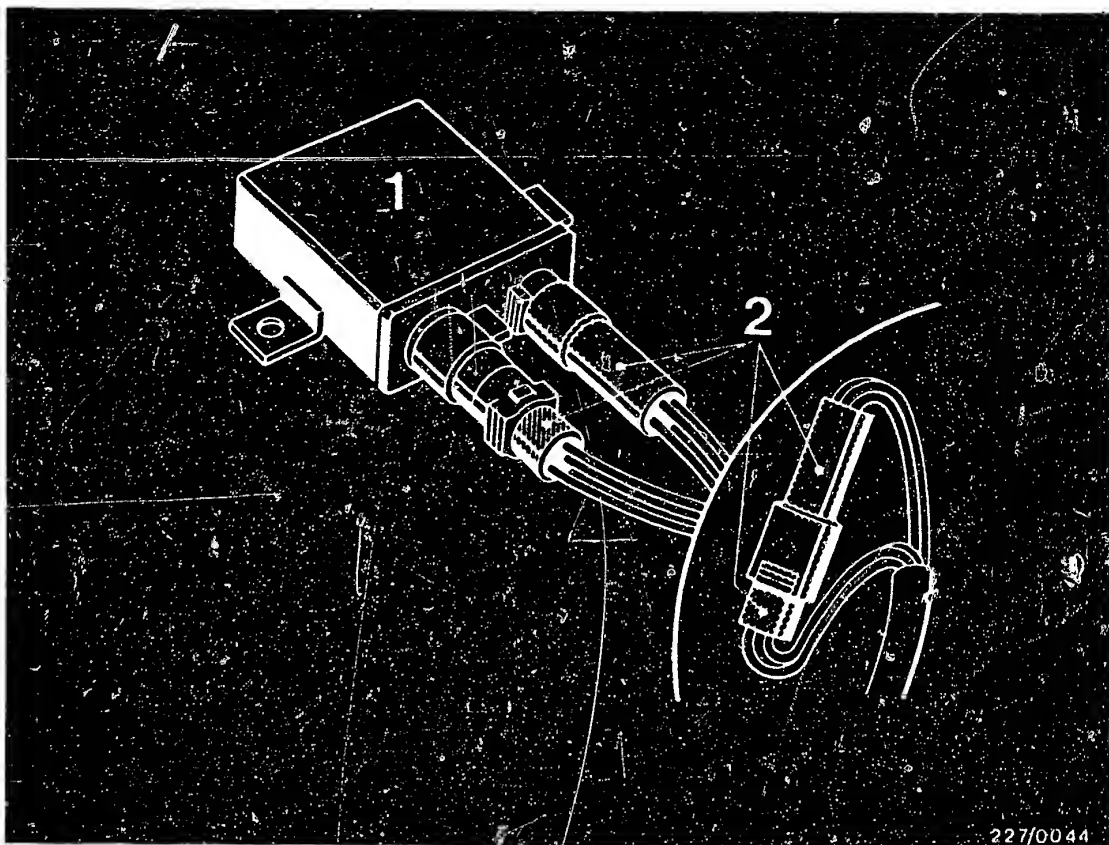
227/0044

Remove both plugs from DLS unit (2) and join together (see illustration). If customer complaint now remedied replace DLS unit. If customer complaint not remedied, continue testing.

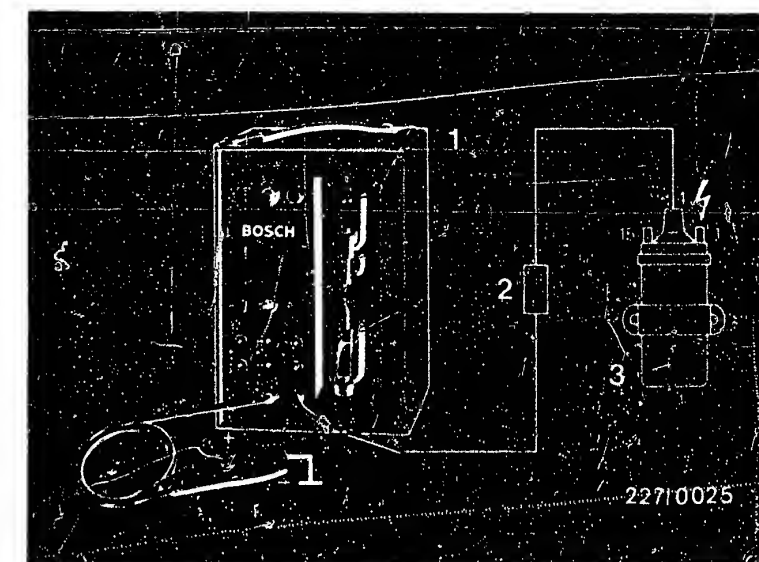
1 = Spark gap

2 = 5 k Ω sleeve-type suppressor

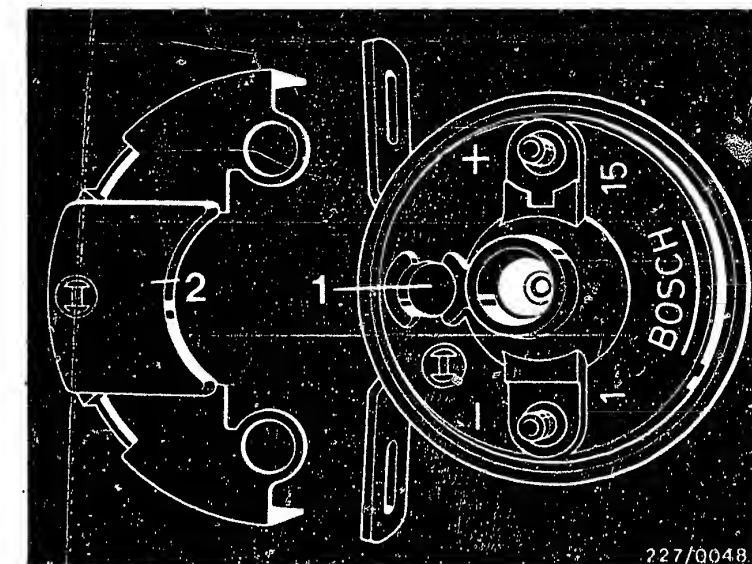
B12

1 = Plug
2 = Protective cap

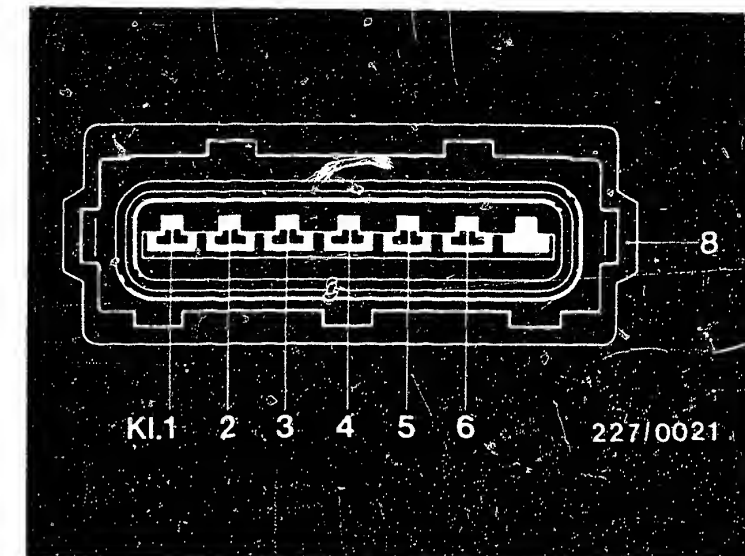
B 14

1 = Trigger-box plug

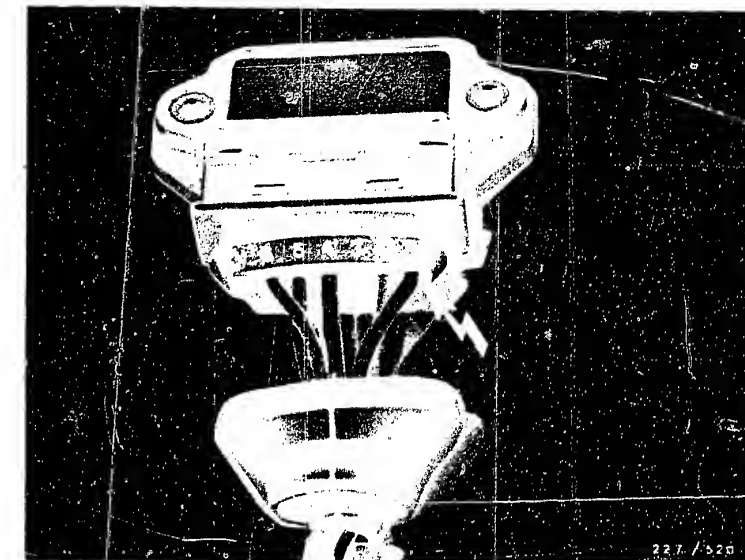
Trigger box with connector

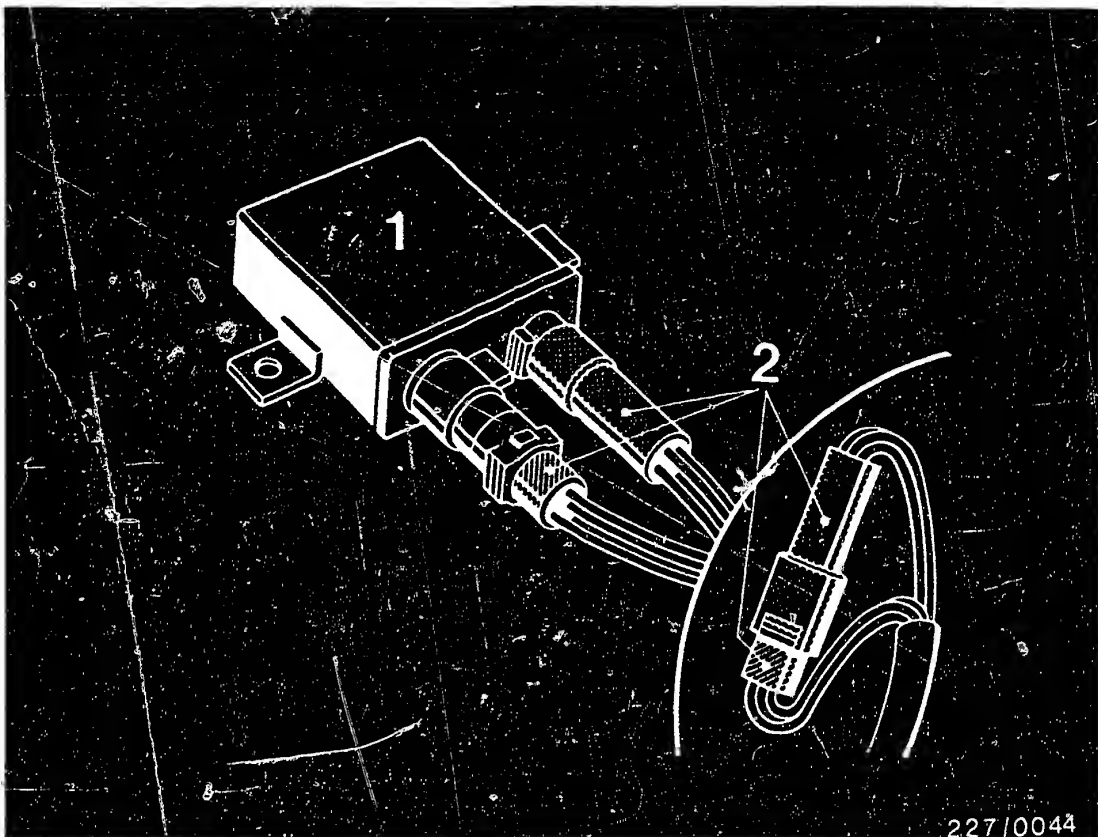
227/0044

- 1 = DLS unit
2 = DLS connector

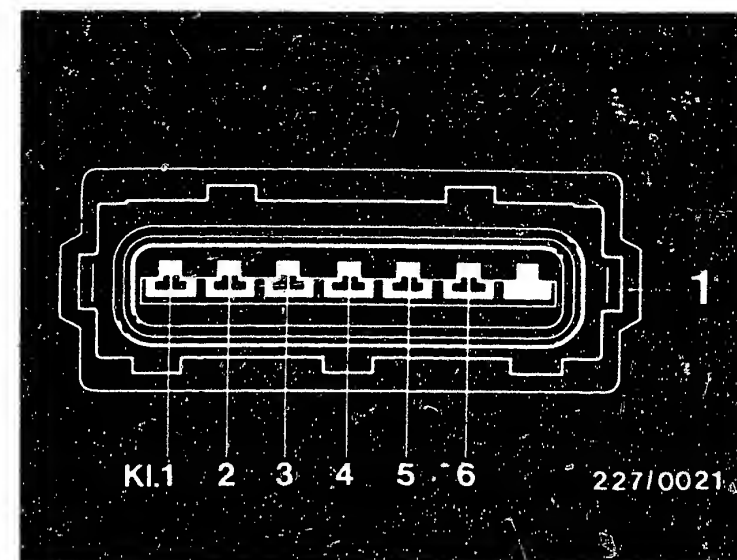
C1

1 = Trigger-box plug

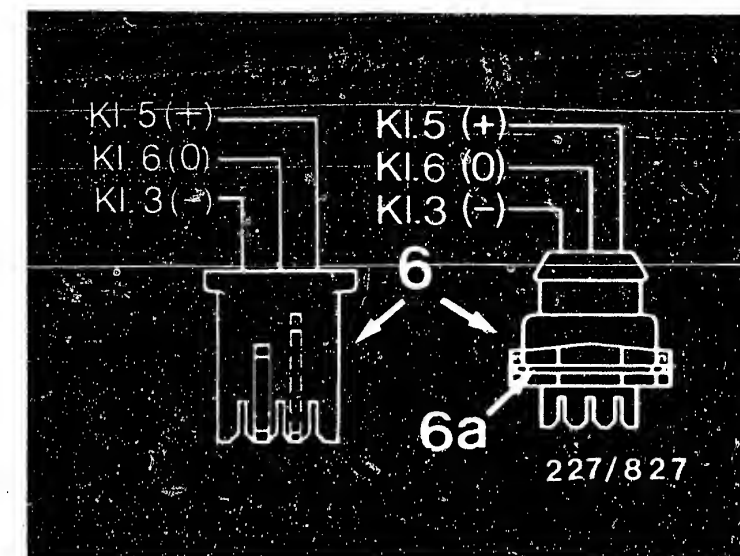
6 = Ignition-distributor plug
Left - old version with
guide lugs
right - new version
6a = Wire retainer

1 = Trigger-box plug

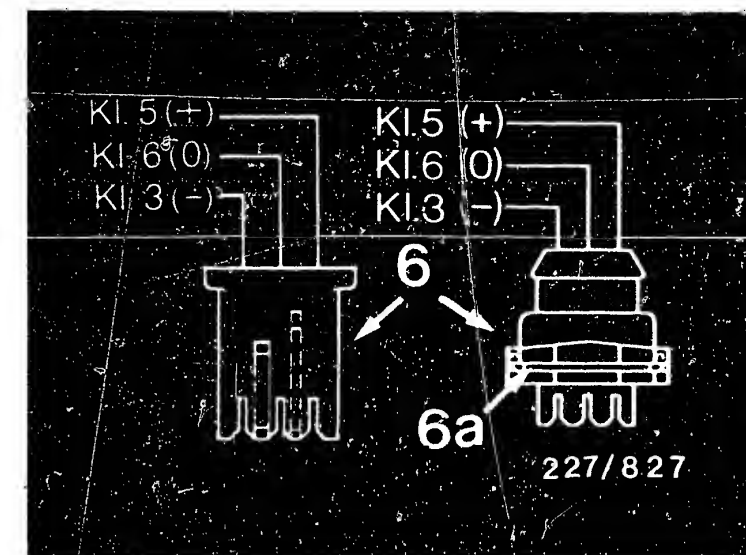
6 = Ignition-distributor plug
left - old version with
guide lugs,
right - new version
6a = Wire retainer

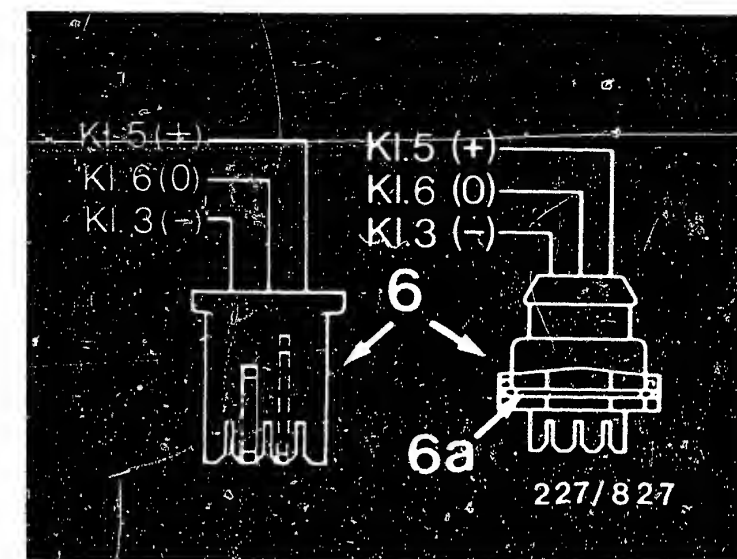
6 = Ignition-distributor plug
left - old version with
guide lugs,
right - new version
6a = Wire retainer

Rectangular pulse

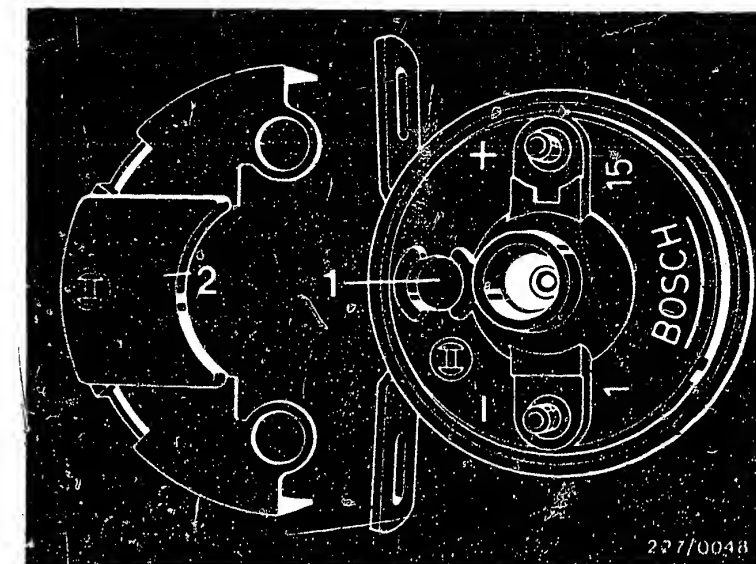
1 = Plug
 2 = Protective cap

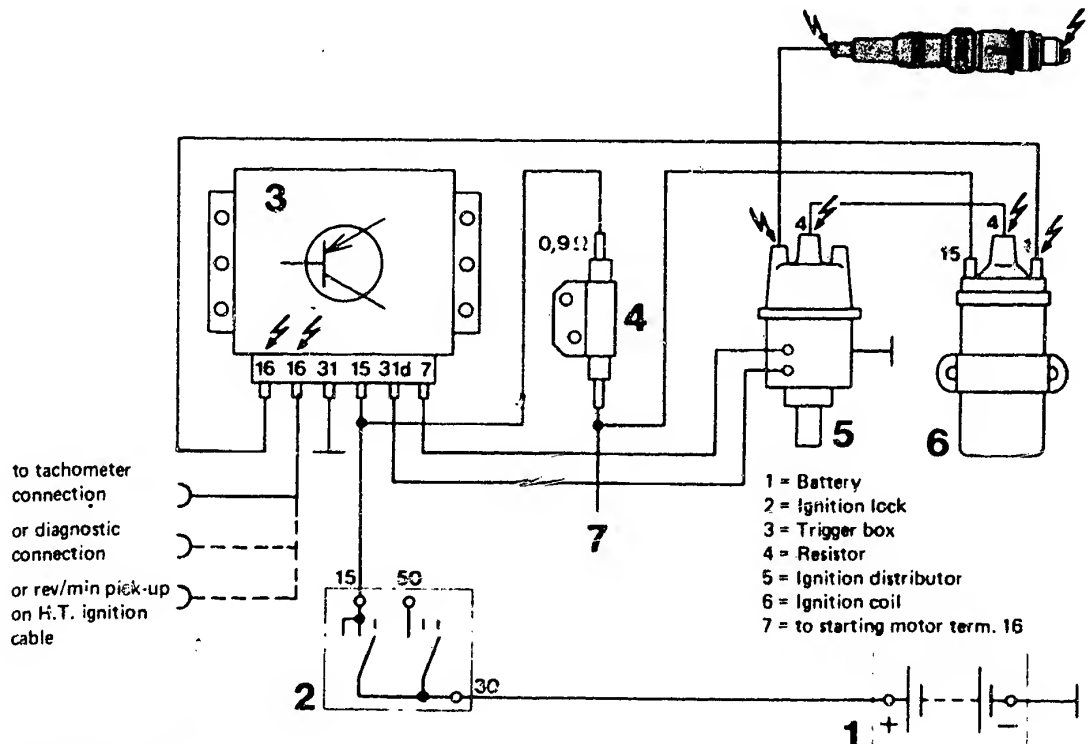
Terminal diagram

Below is a typical terminal diagram of a semi-conductor ignition system, the danger points are marked with red high-voltage arrows. We would point out that all semi-conductor ignition systems, even the older ones, are to be regarded as dangerous in the sense as defined by this bulletin.

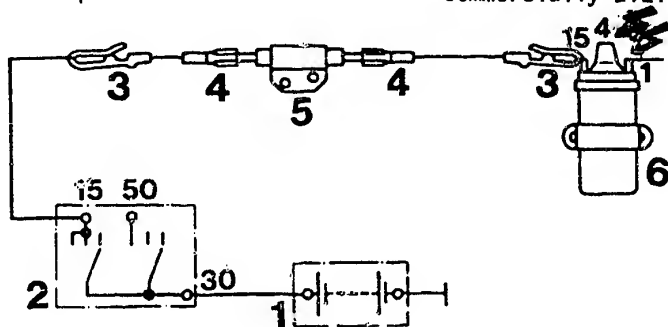
1 = Battery

4 = Blade receptacle

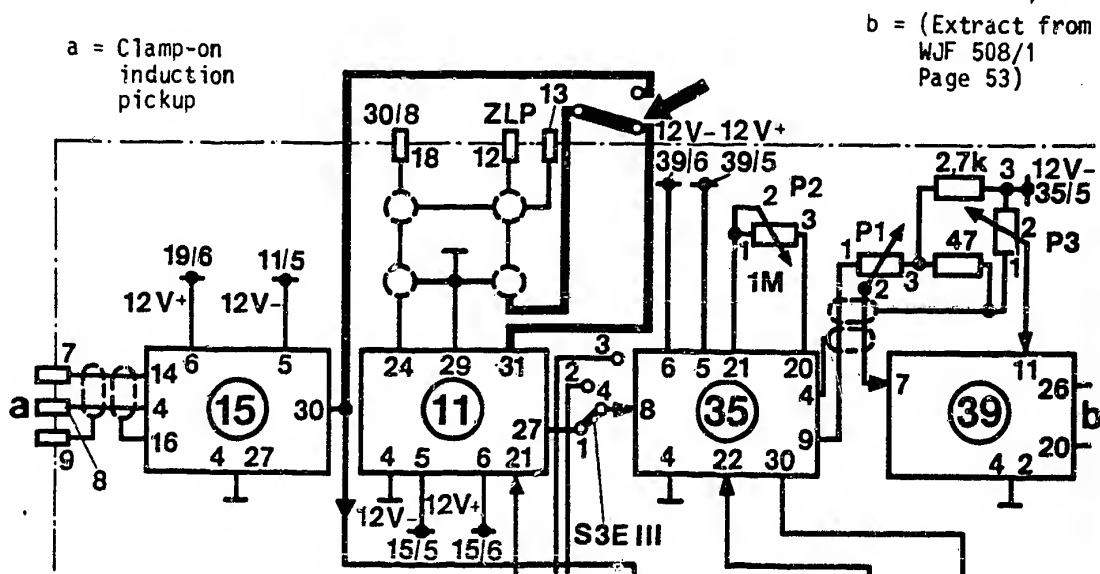
EFAW 214 B

Remove the line of the ZLP* from pin 31 of printed board 11 (coupling stage) and connect to pin 30 of printed board 15 (pulse shaper stage) via a switch with change-over contact (e.g. 0 341 500 803). In addition, a new line must be connected from pin 31 of printed board 11 to the other contact of the switch with change-over contact. Arrow points to switch with change-over contact.

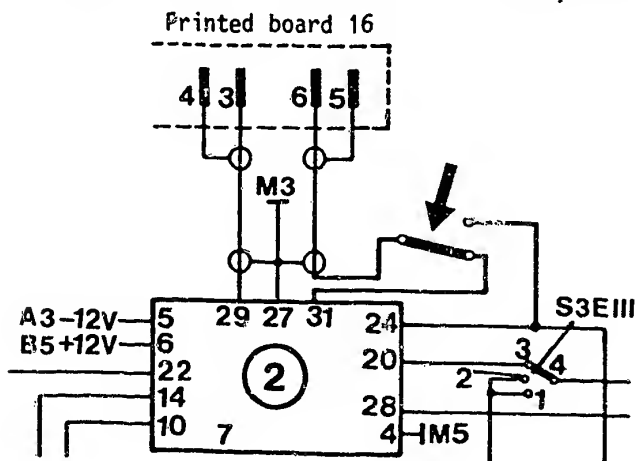
Remove the line from terminal 6 of printed board 15 to pin 31 of printed board 2 (coupling stage) and connect to pin 24 of the same printed board via a switch with change-over contact (e.g. 0 341 500 803). In addition, a new line must be connected from pin 31 of printed board 2 to the other contact of the switch with change-over contact. Arrow points to switch with change-over contact.

By fitting the switch with change-over contact in the front panel of the motor-tester, it is possible to switch over from standard ignition systems to those with current limitation. We recommend that the switch positions be marked correspondingly: e.g. "standard" - "current limitation". These conversion measures have already been published in the K7 information sheet KJF 28/7911.
